GROUNDWATER SOURCE CONTROL INTERIM MEASURES DESIGN ANALYSIS, PLANS AND SPECIFICATIONS EAST HELENA FACILITY

Prepared for
ASARCO Incorporated
100 Smelter Road
East Helena, Montana

March 2000

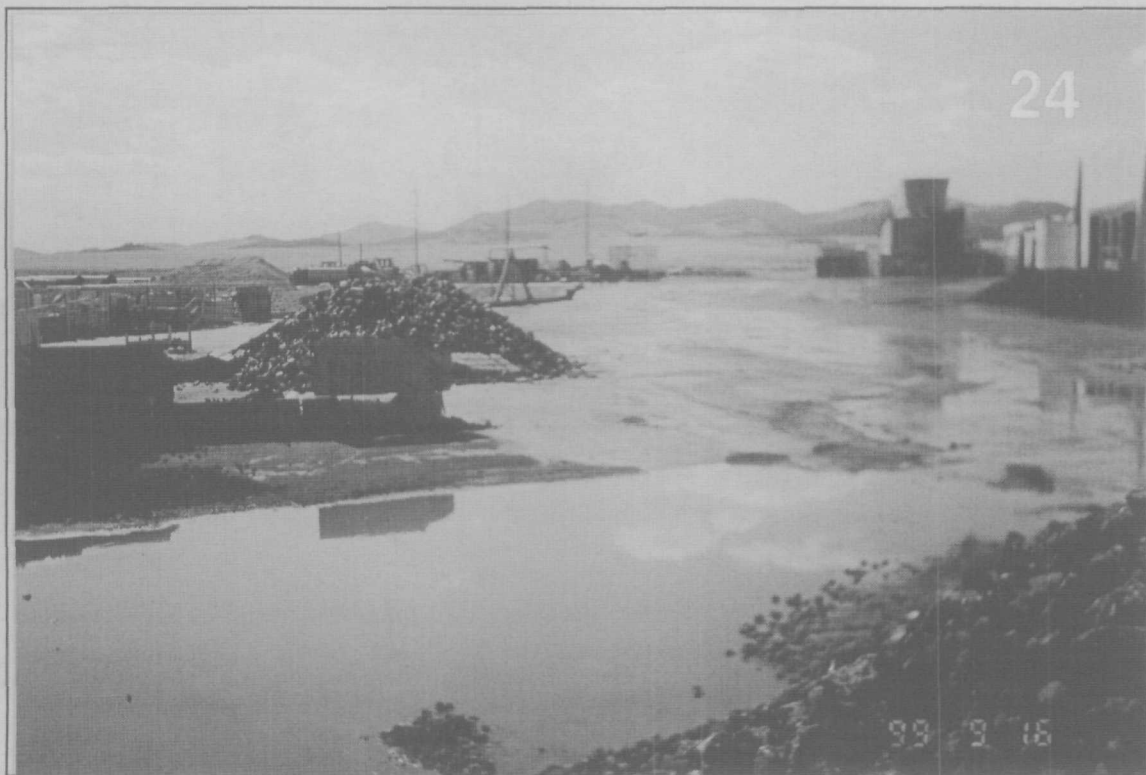
**Ponding on Former Acid Plant Sediment Drying Pad with Water Truck
Fill Station in Background (see Figure 3-1, Number 4)**

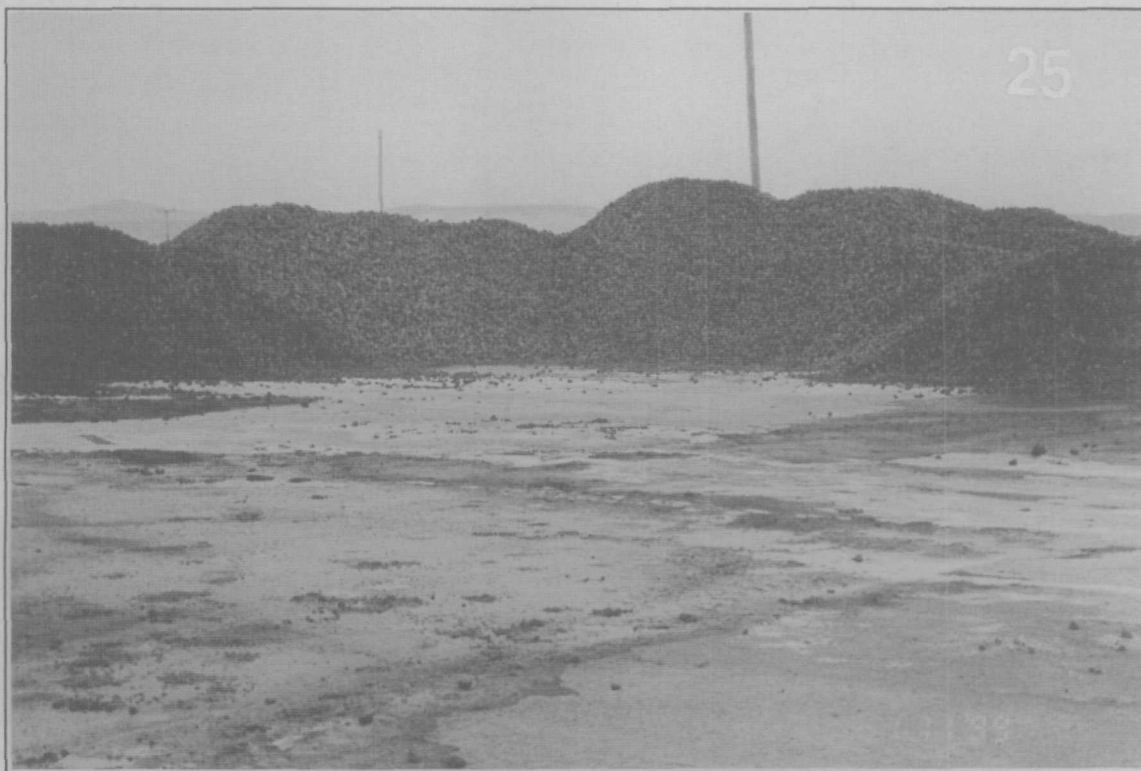
**Ponding on Former Acid Plant Sediment Drying Pad
(see Figure 3-1, Number 4)**

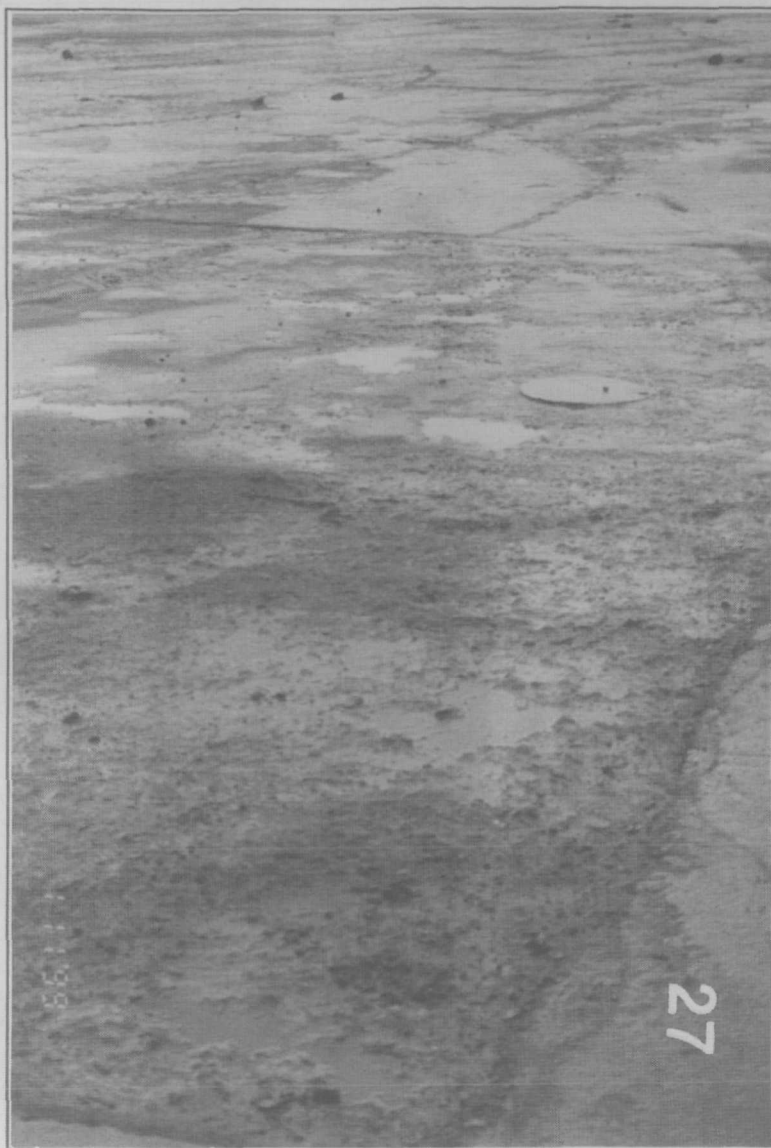
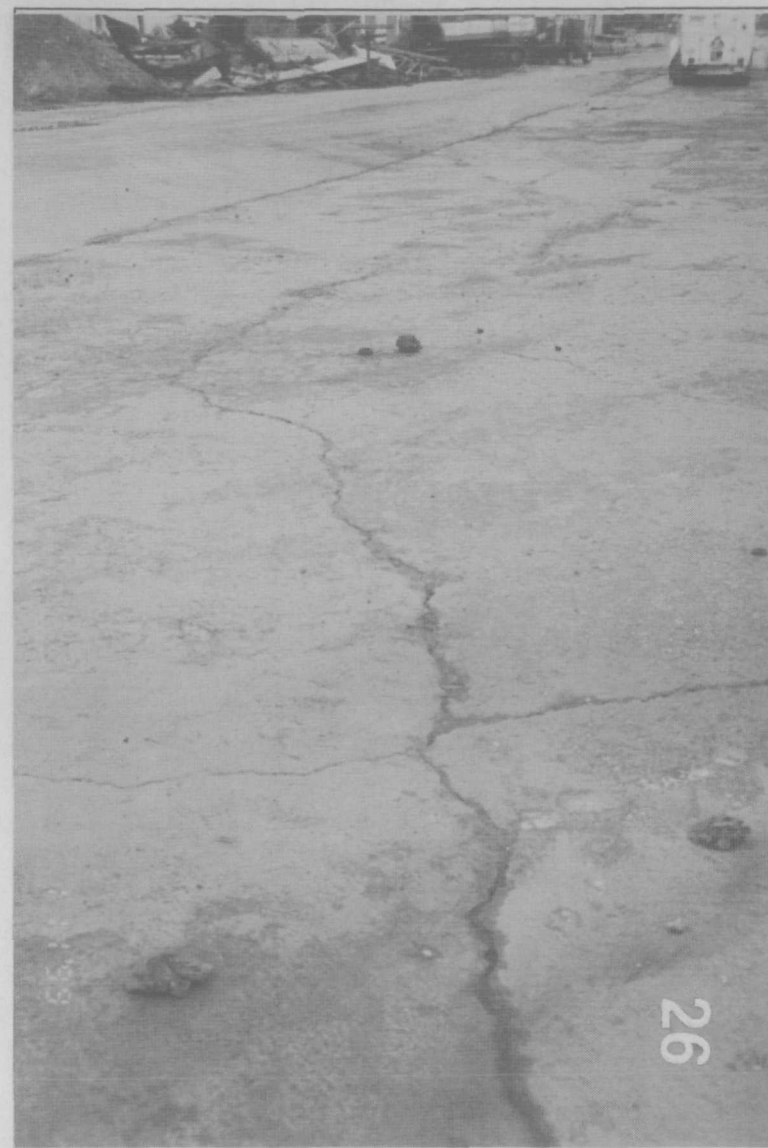
Key Item 6 - Photos 25 and 26 suggest that the concrete is beyond repair. As an alternative, a PVC liner, or similar material, could be laid over the area, or the concrete removed and a lift of fine-grained soil added so that evaporation in the soil profile may be used to reduce the amount of infiltration.

Response: The condition of the concrete in Photos 25 and 26 appears to be worse than it actually is. Patching and crack sealant application should be adequate to address infiltration over most of the Former Acid Plant sediment drying area. The primary concern, however, is eliminating ponding due to excessive run-on from water trucks. As noted in the comment other approaches to address the pad have also been added to Table 4-1.

Cracked Concrete on Former Acid Plant Sediment Drying Pad
(see Figure 3-1, Number 6)
